Xtend 10,13,14 and 16"

Notice: Spline Tube Replacement Procedure - May 2013

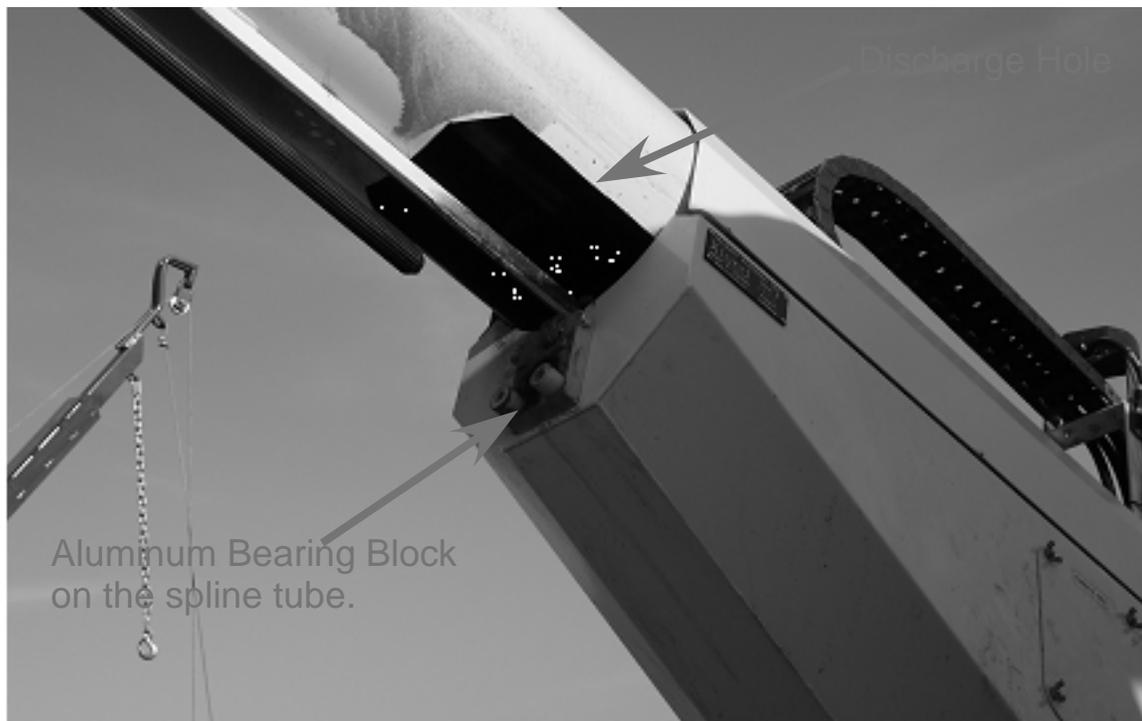
- 1: With tractor or hydraulic source hooked up, retract the swing until you can reach in the discharge hole AND reach the nuts to remove the aluminum bearing housing. As shown in picture below. Shut off tractor.
- 2: Remove 4 bolts on the aluminum block.
- 3: Pry aluminum block off of shaft using 2 pry bars and some cardboard to keep from damaging the paint.
- 4: Remove side cover and remove chain from double chain coupler.
- 5: Replace Tube by hooking up the chain coupler first..
- 6: Drive the aluminum bearing holder on with a wooden block and hammer.
- 7: Lift the chainbox end of the tube OR wedge up with flat screwdrivers to install bolts in block.
(The locknuts go on the socket head capscrews through the plastic spacer)
- 8: Start the tractor and run the swing in and out to ensure proper operation.

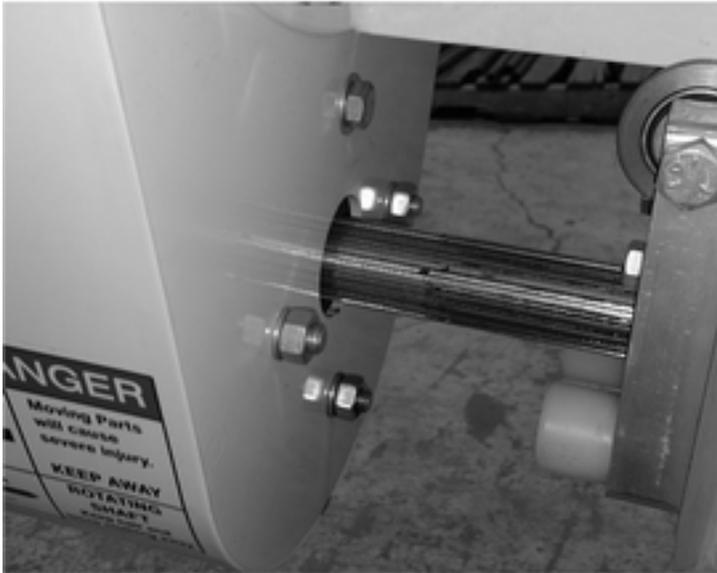
Collector Side Bolts

- 1: Loosen all collector side bolts and outside bolts slightly.
(This can be done carefully with an impact wrench from the outside only, just be careful not to loosen the nut completely as you can lose the bolts inside which will get messy)
- 2: Hydraulically run the shaft into the collector (Get someone to guide the shaft) Until you have just enough room to tighten the collector side bolts with your impact wrench. Tighten the Collector side bolts.
- 3: Retract the swing until the spline shaft is just out of the female spline. Hold the shaft in the center of the hole.
- 4: Tighten the outside bolts.
- 5: Check alignment. Repeat 3 and 4 if necessary.
